Cashman Relies on Fertigation

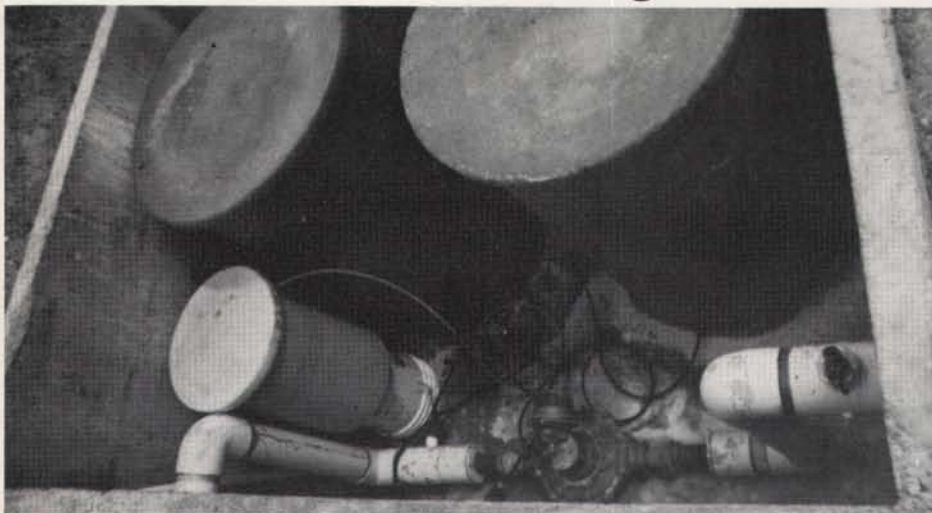
Tanks for liquid fertilizer and injectors in underground vault.

The injectors at Cashman Field are installed in underground precast vaults to protect the equipment from vandalism

and heat. A by-pass is installed to allow for ease of servicing or for periods when non-fertilized water is desired. Two 150 gallon liquid fertilizer storage tanks are installed in the vaults with the injectors. On larger capacity systems, the concentrate tanks can be installed underground near the vaults.
