Turf fields: a drainage solution for under \$250,000

Colorado turf manager deals with flash flood

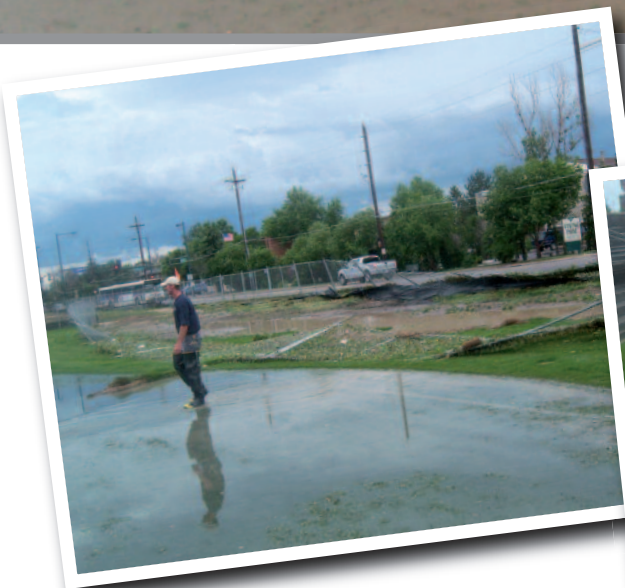
➤ **Left: A WALL OF WATER** breaks down several construction fences.

Here in the suburb of Glendale we are currently building a new park and practice field adjacent and uphill from our stadium, called Infinity Park. Because of all our construction, we had been required to put filters over all of the storm drains and put up both a silt fence and a chain link fence around the construction area. The covered drains couldn't handle the storm water and it built up behind the fencing, reaching a level of nearly three acre feet of water. Then it broke through, sending a

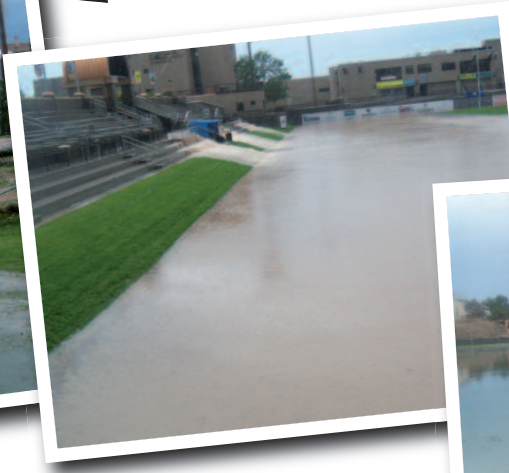
➤ **Middle: WATER** began to flood Infinity Park at 2 pm.

At 2:14 pm, more than 2 feet of water covered the stadium pitch. We have cleanouts at all four corners, positioned off the pitch surface. They tie into 8-inch drainpipe that then joins into the city's main 12-inch drain line. We pulled the cleanout covers and used push brooms to try to keep the silt agitated in the water to keep it off the field surface. The water was coming on the field faster than those drains could handle it, so we had to keep clearing clogs there to keep it flowing. By 6 pm we were down to 2 inches of water on the perimeter of the field.
