Renovation Down Under: Australian Golf Course Fights for Perfect Couch

By Jonathon Scott

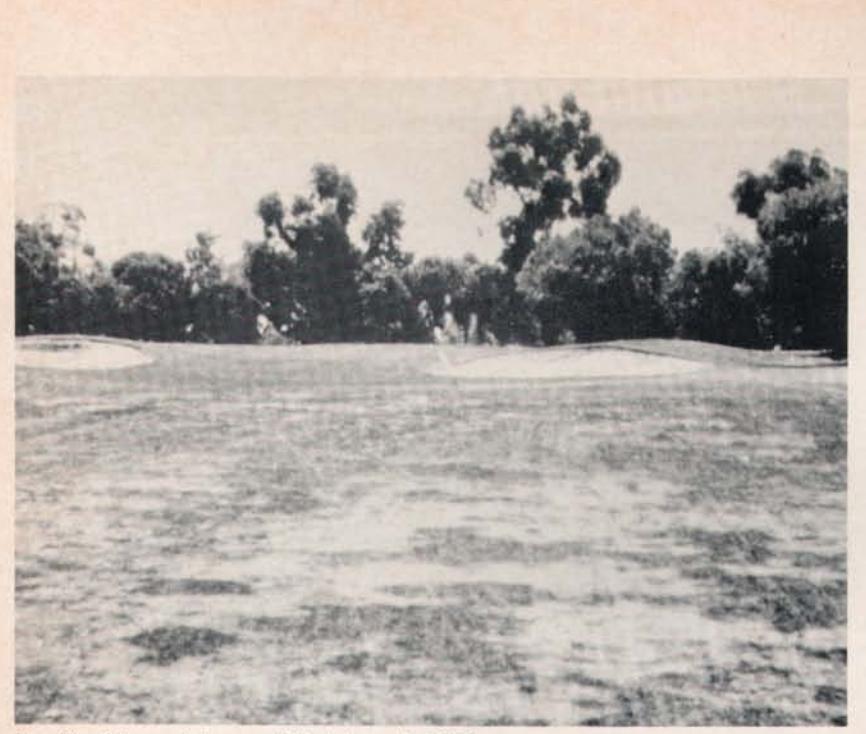
Localized dry patches on 17th fairway in 1986.

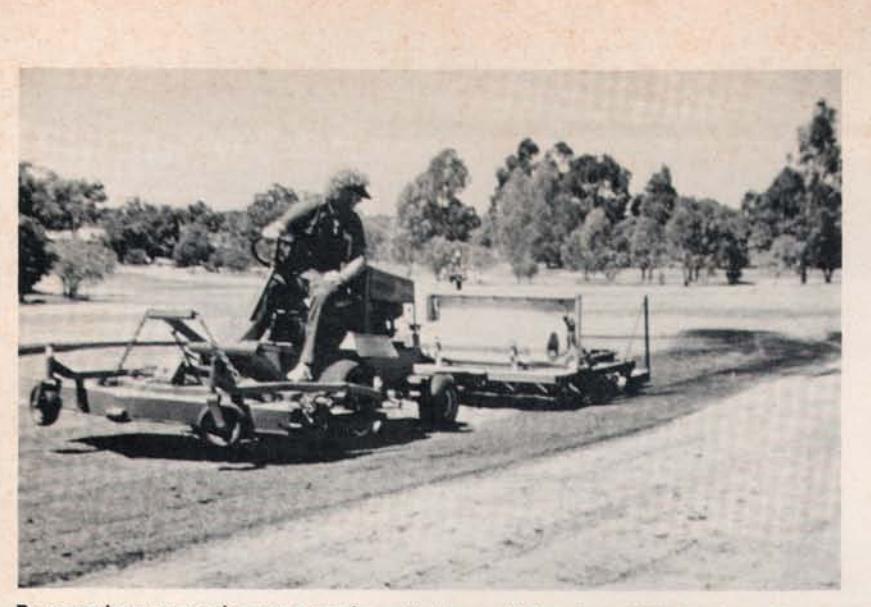
What I didn't want, however, was to add to the decomposition problem. I had experimented with a propane burner built by a gas company for the purpose of weed control and thatch burning. I learned that a speed of about six mph would burn off the dead leaf tissue without harming the couch. Unfortunately, the unit was destroyed in an accident in transit to the club. I still believe that the principle is sound and will definitely use this machine in the future.

Propane burner used as an experiment to burn off thatch and kill fungi on fairway.
