## Improving native soil athletic field drainage

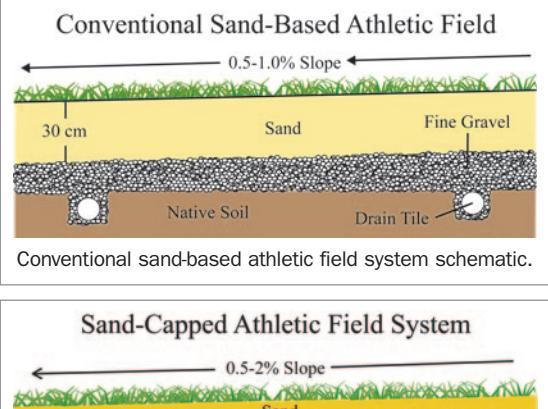
Sand-capped athletic field system schematic

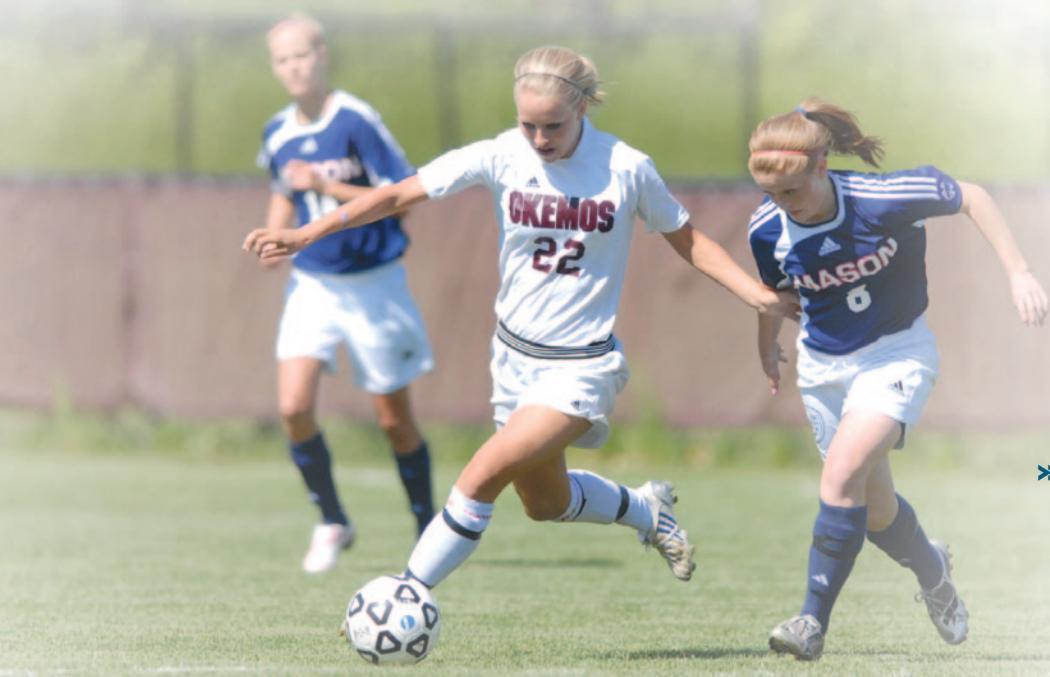
OKEMOS HIGH SCHOOL SOCCER FIELD, Okemos MI May 20, 2009. Drain tiles were installed at 8-foot spacing in May 2008 and 1 ½ inches of subsequent sand topdressing has been accumulated since.

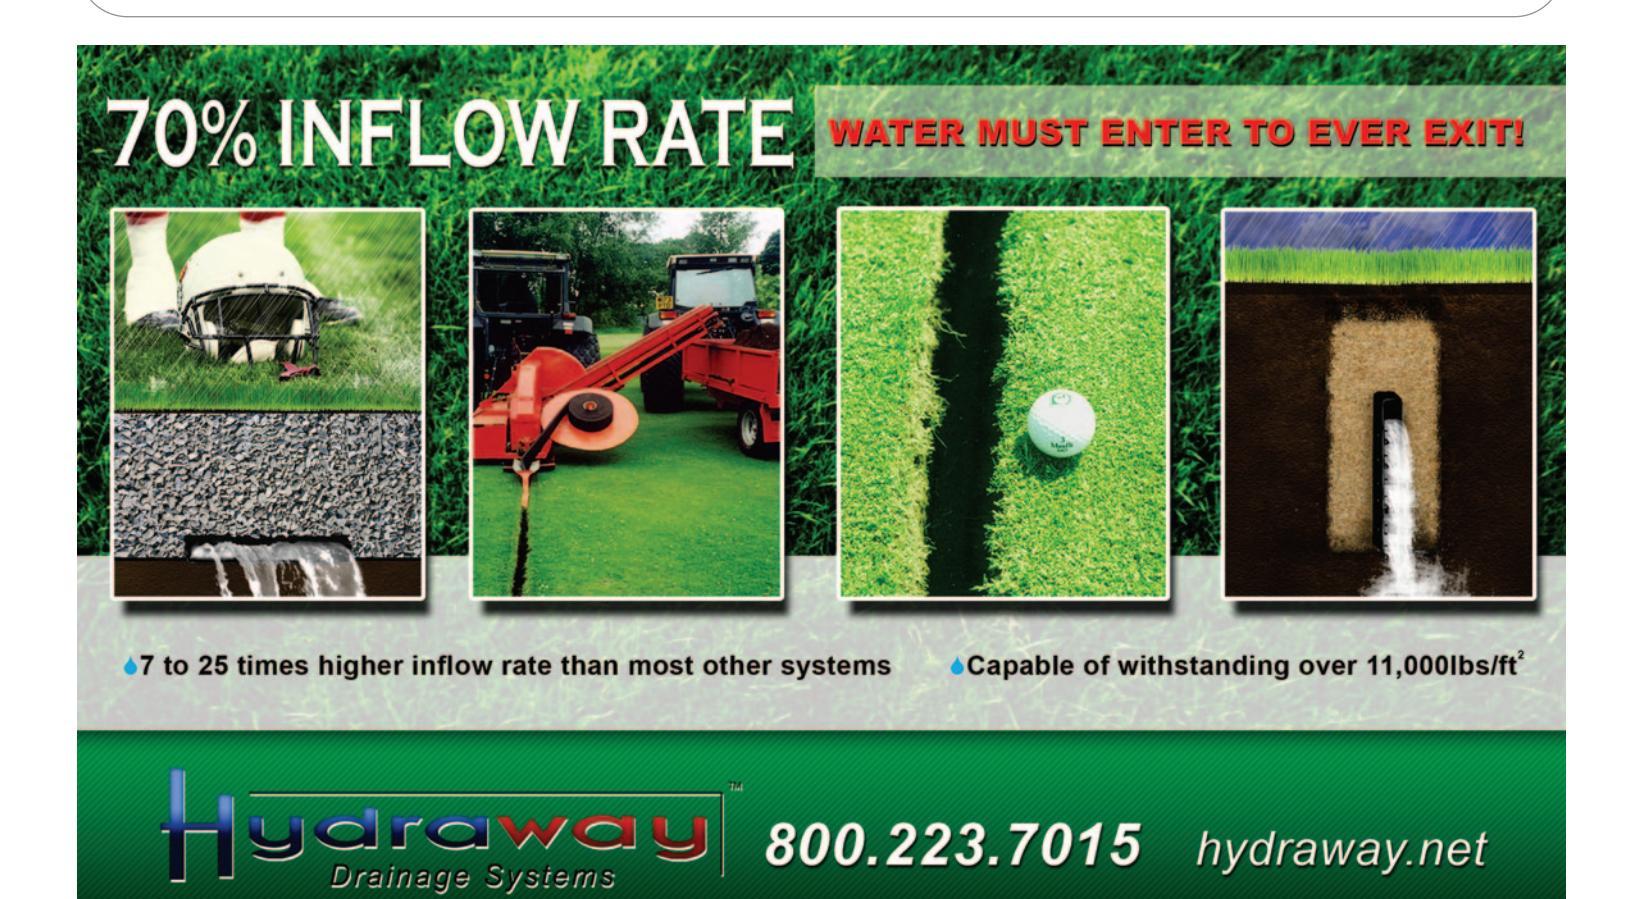
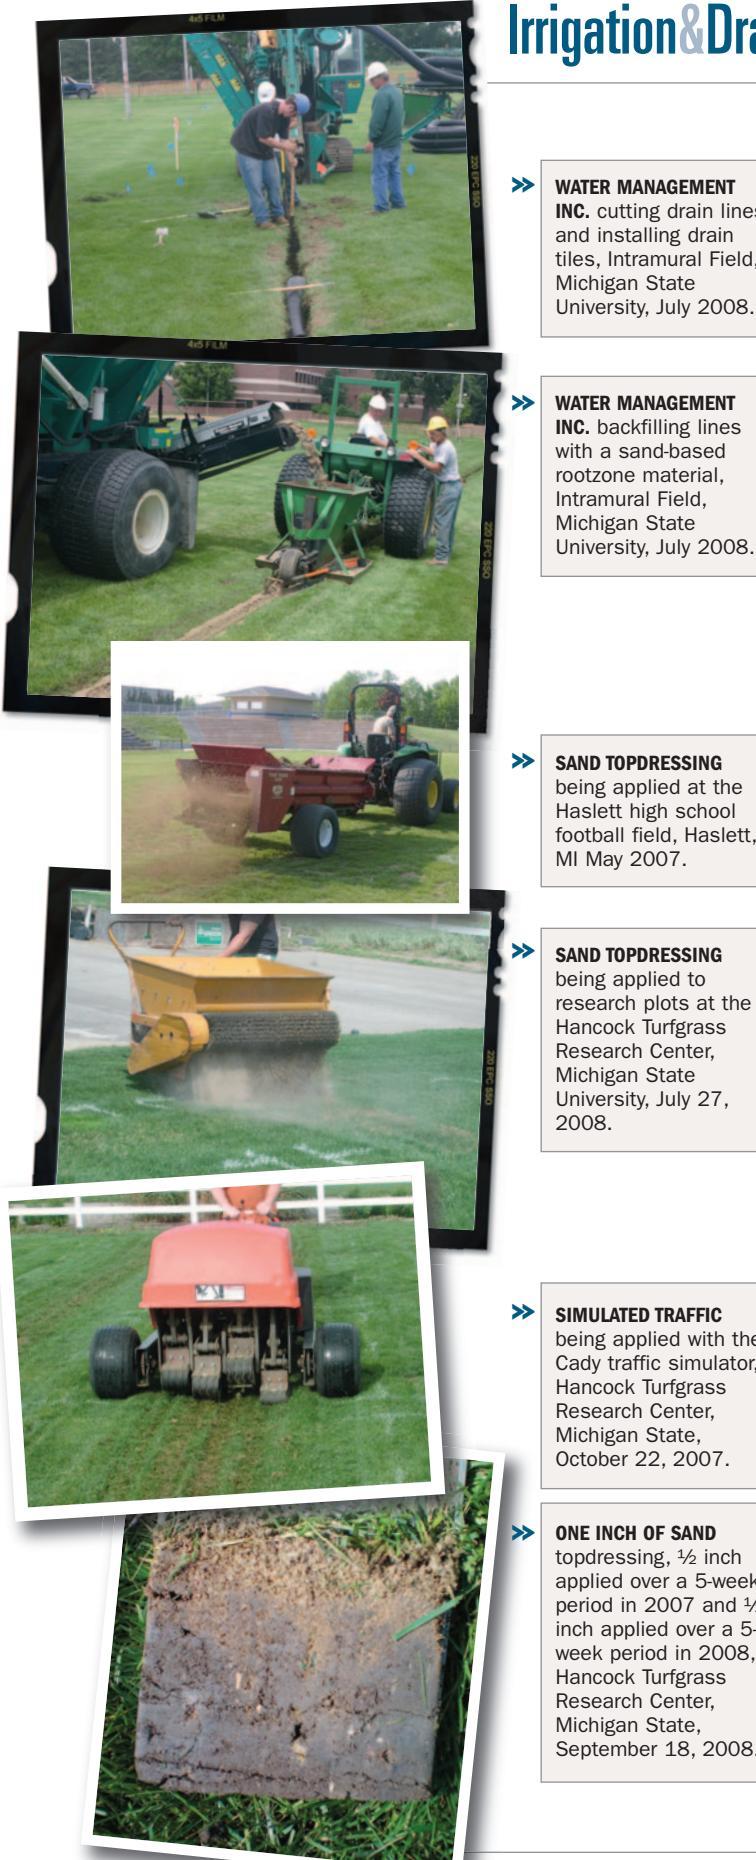
WATER MANAGEMENT INC. cutting drain lines and installing drain tiles, Intramural Field,

WATER MANAGEMENT INC. backfilling lines with a sand-based rootzone material, University, July 2008.

being applied at the Haslett high school football field, Haslett,

research plots at the Hancock Turfgrass Research Center, University, July 27,

being applied with the Cady traffic simulator, Hancock Turfgrass Research Center, October 22, 2007.

ONE INCH OF SAND topdressing, 1/2 inch applied over a 5-week period in 2007 and 1/2 inch applied over a 5week period in 2008, Hancock Turfgrass Research Center, September 18, 2008.

projects received sand topdressing applications in the summer, applied over a 5-week period at a 1/4 inch per application, and simulated athletic field traffic, applied using the Cady traffic simulator.
